Navajo Abandoned Uranium Mine Site Screen Report

Section 25

Navajo AUM Eastern Region

Weston Solutions, Inc.

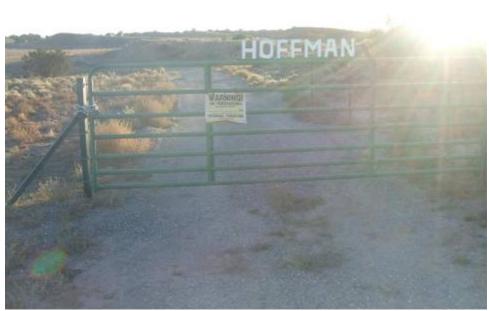
Photo 1. Locked gate on road leading towards Section 25 mine site

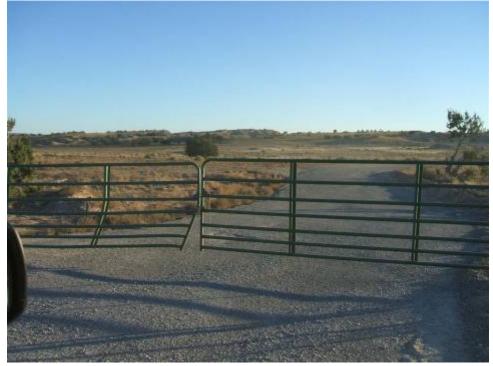
Photo 2. Locked gate leading towards Section 25 mine site

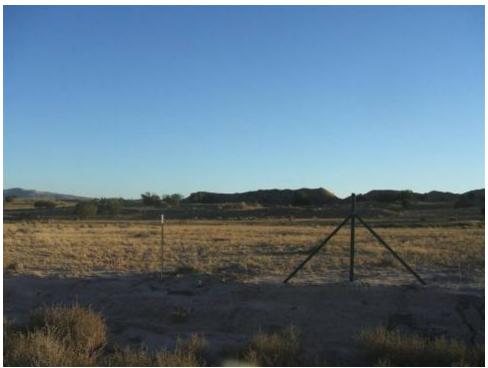
Photo 3. Fenced area leading towards Section 25 mine site

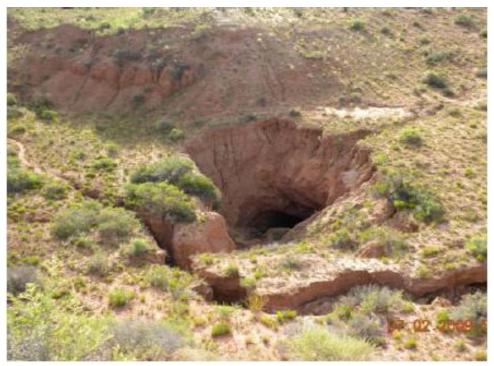
Open pit area (Section 25 #363) adit

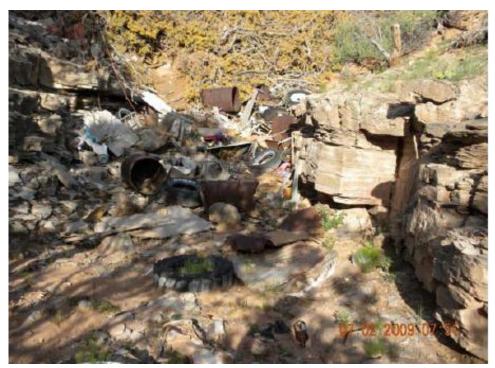
Open pit area (Section 25 #363) bulldozer cut into limestone, current trash dump area

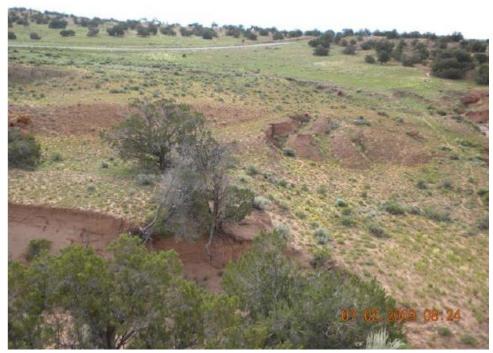
Open pit area (Section 25 #363) facing east towards possible reclaimed area

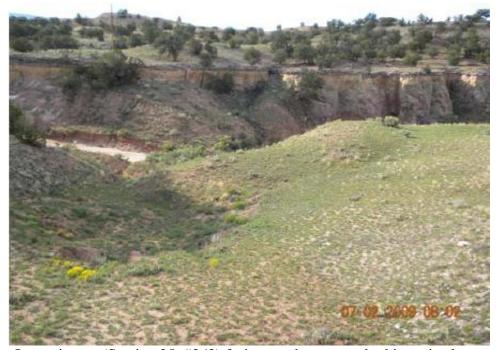
Open pit area (Section 25 #363) facing southeast, overlooking mined area

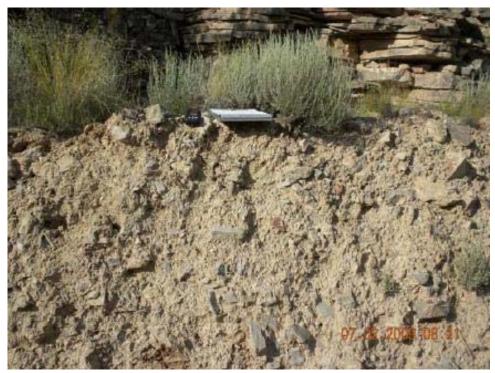
Open pit area (Section 25 #363) waste rock near drainage

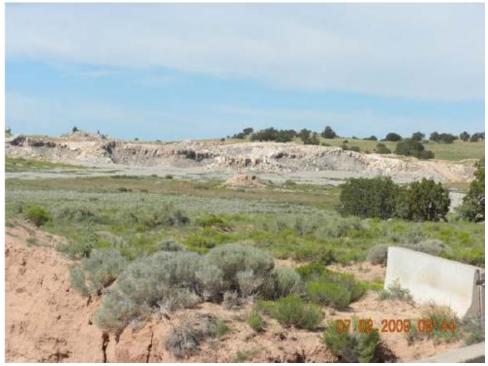
Aggreagate pit area (Section 25 #366) facing the southwest

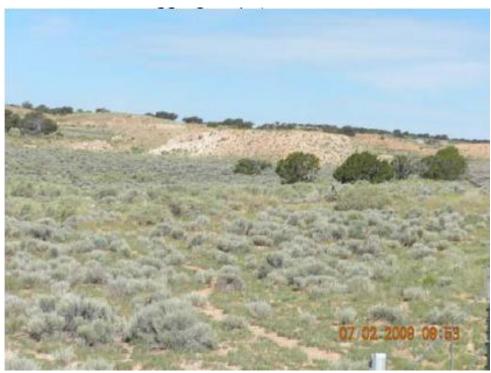
SEQ area (northwest corner of Section 25 #366) facing the west
